**COMPREHENSIVE NEEDS ASSESSMENT FOR  
CHINOOK SALMON HABITAT IMPROVEMENT PROJECTS  
IN THE SAN JOAQUIN RIVER BASIN**

March 1994

Prepared for the California Department of Fish and Game  
by the  
California Department of Water Resources' San Joaquin District  
under Contract FG20841F/165038

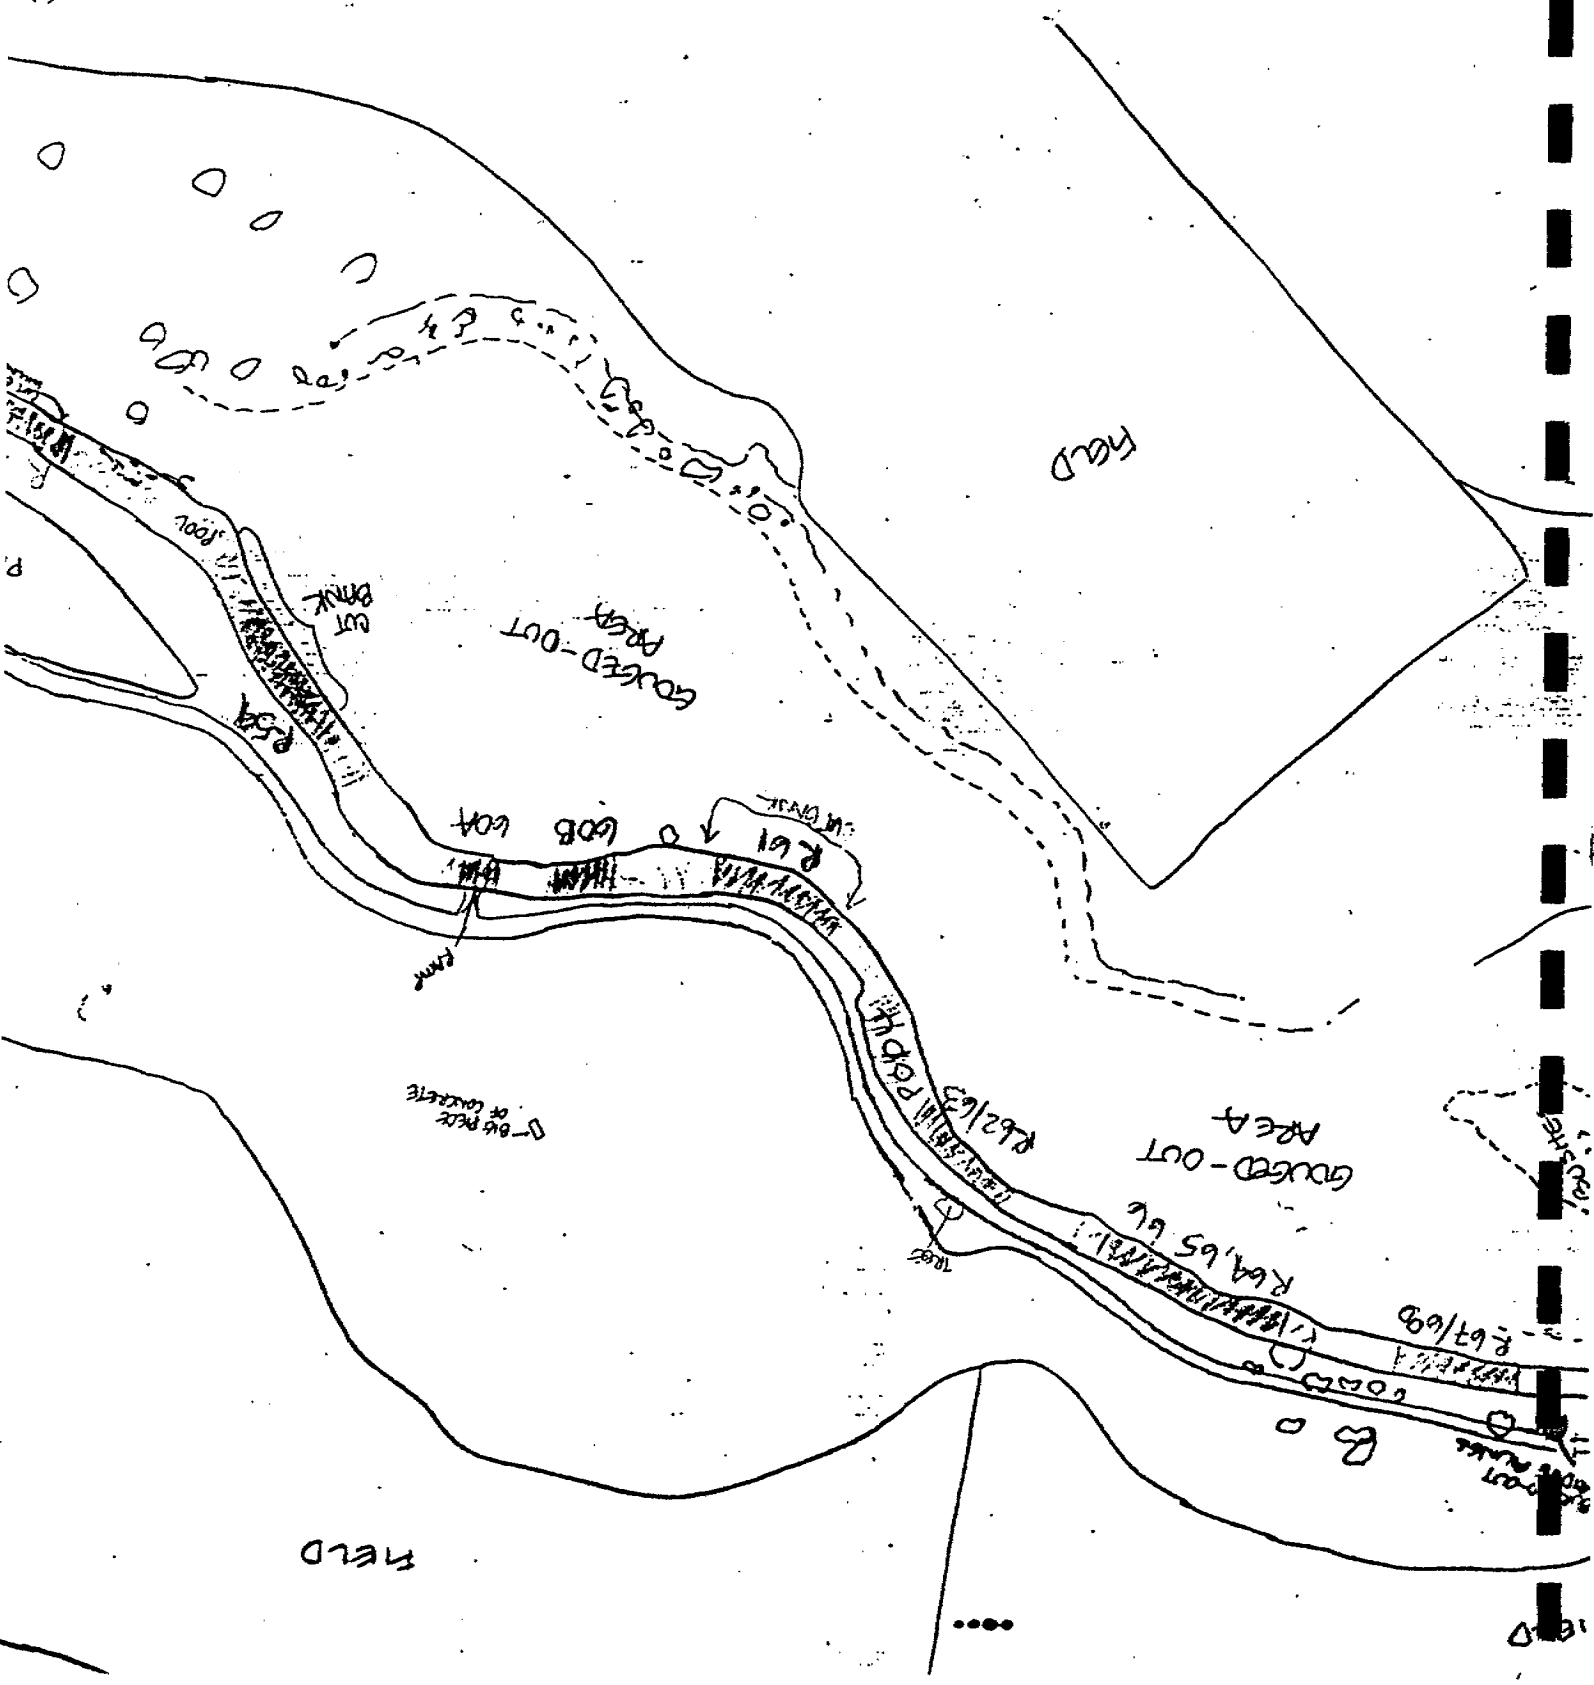
**Merced River  
Mile 40.1-40.5**

Approximately 200 acres of abandoned gravel pits have breached, and the river now passes through them. These pits provide prime habitat for predators of out-migrating salmon smolts.

| River Mile | Riffle | Approximate Length or Area | Habitat Type | Site Description | Project Description | Rank (B+E)* |
|---|---|---|---|--|---|---|
| 40.1-40.5 | | 2,500 feet<br>200 acres | Predator | Huge ponds. Potentially significant benefits. | Minimal levee repair relative to benefits. | 1+1 |
